Baseline Environmental Assessment: Rural Tributaries of the Ahuriri Catchment 2024

Ahuriri Tributaries Catchment Group Trust

• November 2024

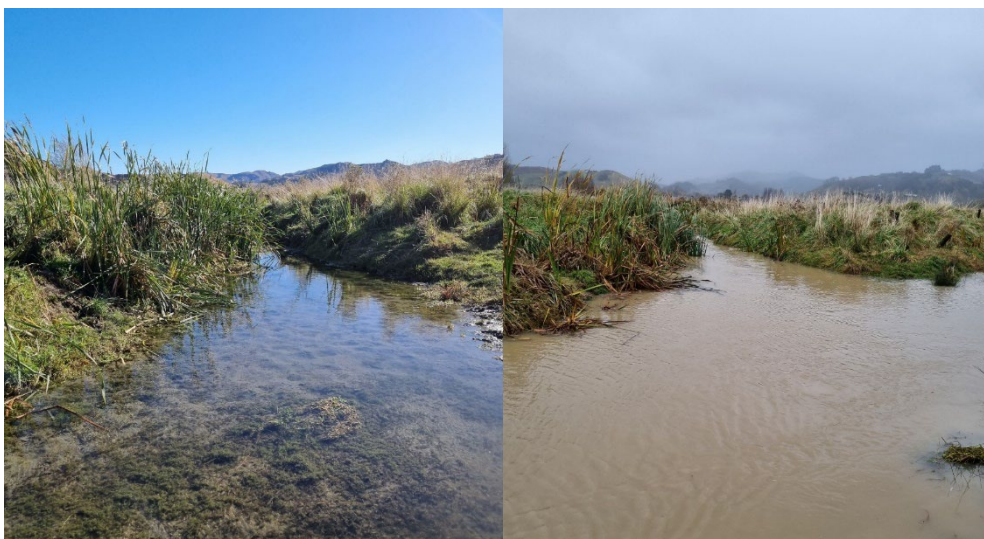
Photographs of Site T6 during dry (left) and wet (right) weather, showing the decreased water clarity during wet weather as a result of increased sediment load, that was a common occurrence across all lower catchment sites (see Appendix A).

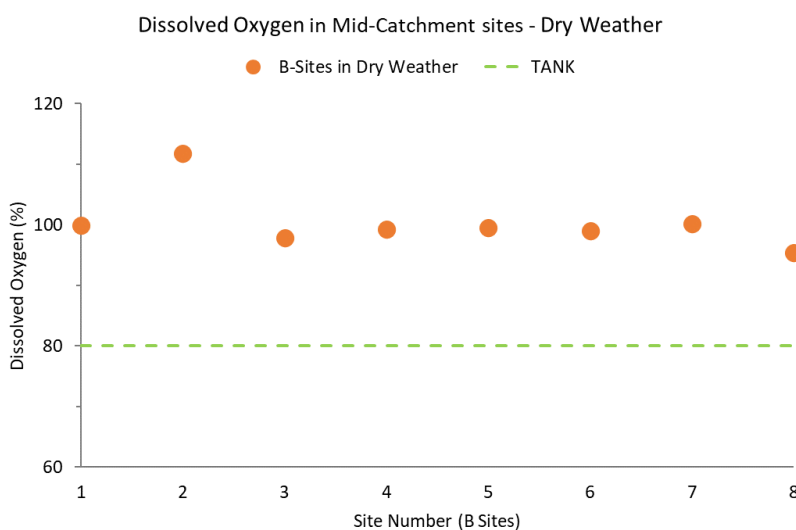
Dissolved oxygen in the mid-catchment sites were all greater than the TANK guideline values, meeting the target attribute state (Figure 3). Dissolved oxygen at the B2 site (111.8%) was notably higher than the other sites (ranging from 95.4% to 100.1%). The range measured is within a healthy range for freshwater streams, however as the measurements were taken in the late morning, they are likely to miss the Dissolved Oxygen minima that is experienced in the early morning.

Figure 3: Dissolved Oxygen (DO) levels across the mid catchment sites (B sites), as compared to TANK guidelines.

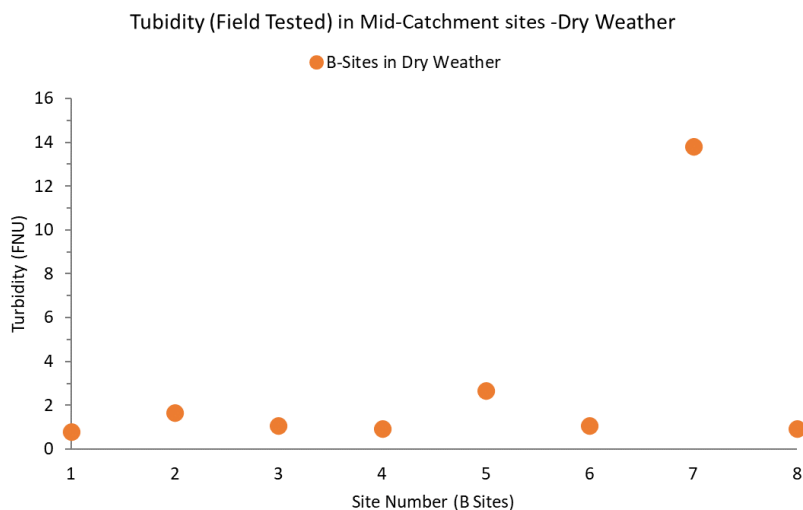
Turbidity for the mid catchment sites in dry weather, as shown by Figure 4 tended to measure at low levels (below 3 FNU) for all but one of the mid catchment sites during dry weather. B7 had a higher turbidity of 13.8 FNU.

Figure 4: Turbidity of the mid catchment sites (B sites)

Site B7 had higher turbidity than the other B sites. This indicates a potential sediment source. At the time of monitoring, there were visual indicators suggesting that earthworks had been conducted in the stream at this site, the likely cause of the increased turbidity.

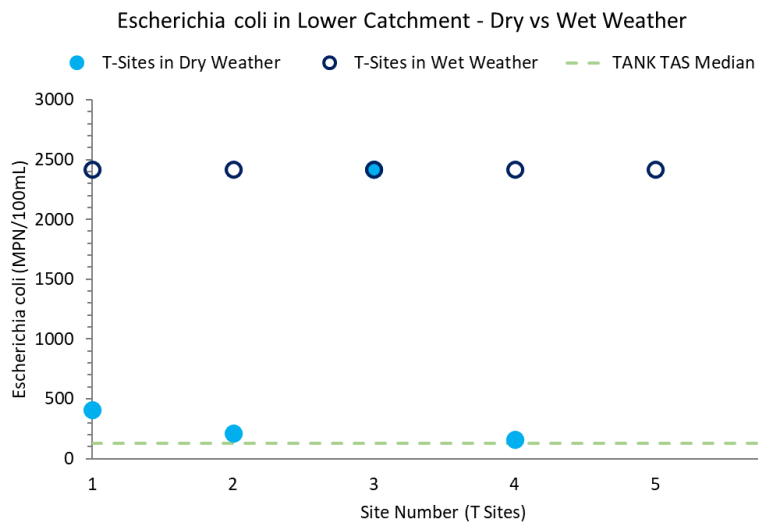
Escherichia coli (*E. coli*) exceeded the TANK Target Attribute State (TAS) median at all sites in both weather conditions (Figure 6). The laboratory upper detection limit for *E. coli* (2,420 MPN/100mL) was reached in all wet weather samples, and at T3 in dry weather. This suggests high levels of faecal material can be transported to the waterways during rainfall.

Figure 6: *Escherichia coli* (*E. coli*) in the lower catchment (T sites) against TANK guidelines. A comparison between dry and wet conditions.

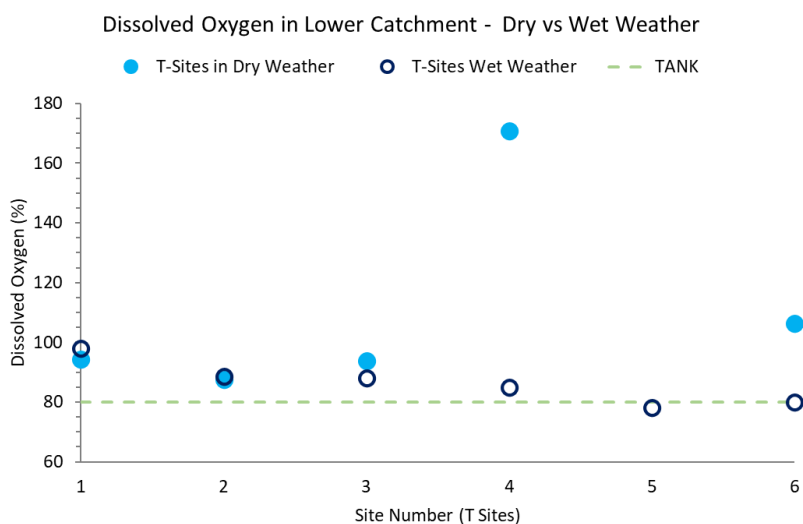
Dissolved oxygen in dry weather conditions was within the target attribute state for all sites, however in wet weather conditions, sites T5 (78.2%) and T6 (79.9%) were below the guideline value (80%) (Figure 7). The dissolved oxygen at T4 is noticeably high in dry weather, with a reading of 170.9%. High levels of macrophyte growth at these sites may provide further information about these levels (discussed below).

Figure 7: Dissolved Oxygen (DO) in the lower catchment (T sites) against TANK guidelines. A comparison between dry and wet conditions.

Sites T5 and T6 had dissolved oxygen levels below guideline values during wet weather conditions. This is also an indicator of high macrophyte growth. During wet weather conditions, rainfall increases flow within the stream, and allows for greater interaction between the water and the atmosphere, creating aeration as it moves through the stream channel, resulting in oxygenation of the water. For dissolved oxygen levels to be lower under wet weather conditions, indicates that dissolved oxygen is likely being consumed by respiring plants and organisms, more quickly than oxygen is being gained. There are also visual observations represented in both the RHA's and photographs from T5 and T6 that support the observation of high macrophyte growth. In the RHA's, macrophytes are recorded in the fish cover abundance attribute, with condition scores of 6 (T5) and 9 (T6) (see appendix E, Tables E13 and E14). T5 (Appendix A, photographs 17 and 18) has visible reed like macrophytes growing within the stream bed and along the banks. While at T6 (Appendix A, photographs 19 and 20) there are visible aquatic plants along both the stream bed and stream banks.

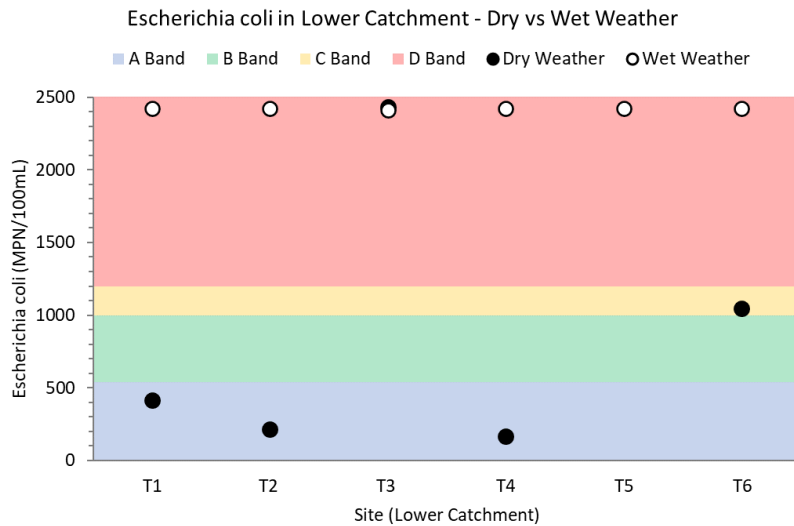
E. coli in the lower catchment had values within three different attribute band ranges. In dry weather, T1, T2 and T4 had *E. coli* levels within the A Band range, while T6 was within the range of Band C. T3 had values in the range of Band D for both dry and wet weather, with all wet weather samples presenting *E. coli* levels coinciding with the Band D value range. Again, it is important to note that

the NPS-FM and TANK bands are expected to be used for longer term monitoring datasets, where medians, and percentiles that comply with different requirements can be calculated. The bands depicted below are for the 95th percentiles of data, and therefore longer term monitoring data may indicate that dry weather levels do not comply with Band A for other statistics.

Figure 13: Escherichia coli (E. coli) in the lower catchment (T sites) against TANK TAS attribute bands. A comparison between dry and wet conditions.

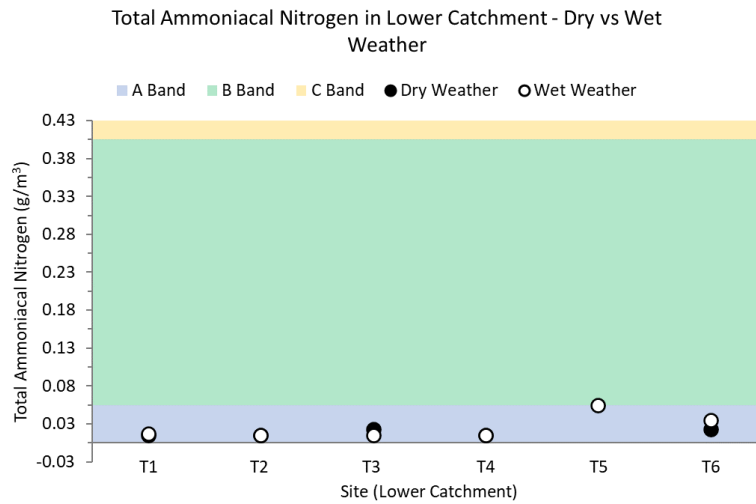
Ammonia toxicity was measured as within the range of attribute Band A, for all sites under both weather conditions (Figure 16). Again, this is a measure of toxic effects as opposed to nutrient enrichment.

Figure 16: Total ammoniacal nitrogen (NH4N) in the lower catchment (T sites) against TANK TAS attribute bands. A comparison between dry and wet conditions.

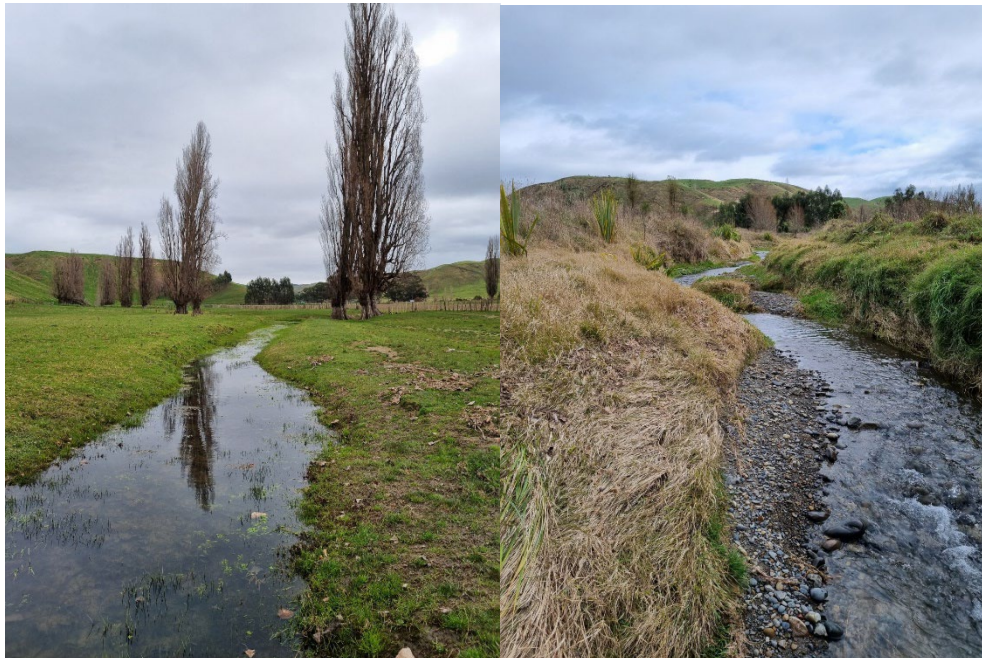
The lowest vs highest scoring sites, B2 and B3 respectively, are visually represented in Figure 22 below. Site B2 (left) is situated in a sheep holding paddock, with no visible flow. It is seen to be a soft bottomed stream bed (sediment covered), with no riparian margin. Site B3 has sparse plantings of young, native vegetation growing in a fenced riparian margin. The stream has visible flow, including runs, riffles and rapids, over a hard bottomed stream bed of gravel, cobbles and boulders. There are visible undercut banks and encroaching vegetation from elevated stream banks.

Figure 22: Photographs of lowest scoring vs highest scoring sites for Rapid Habitat Assessments. Site B2 on the left, a score of 18. Site B3 on the right, a score of 71.

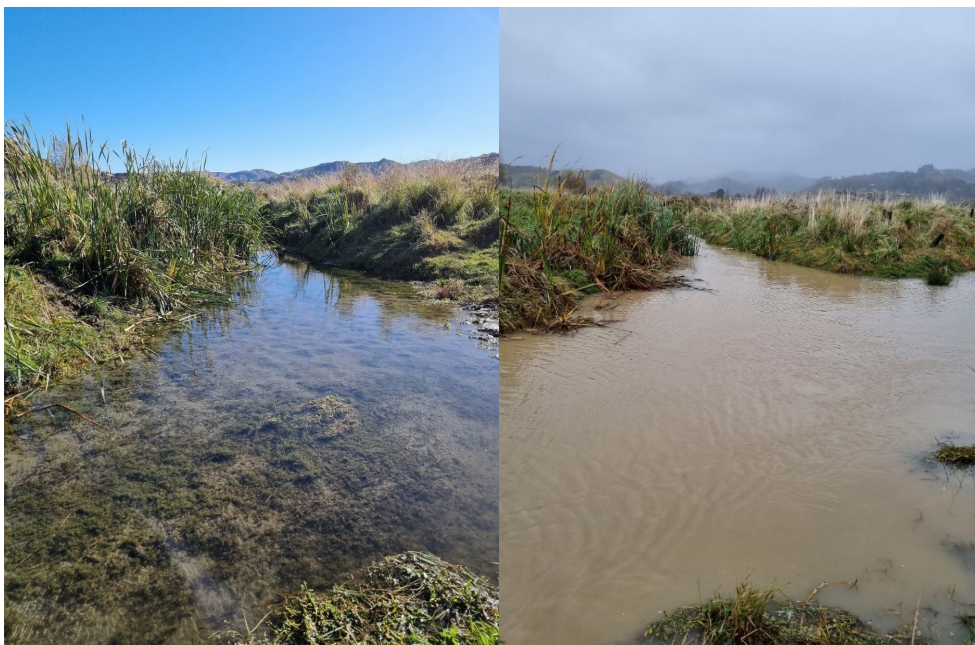
Turbidity readings in the lower catchment were highly elevated in wet weather conditions, particularly at sites T1, 2, 4 and 6. Turbidity is a measure of water clarity, and an indicator of suspended sediments within the stream. The elevated results are likely the result of erosion within the catchment, exposing loose sediments that are carried into the stream by stormwater run-off. These high suspended sediment loads during wet weather were noticeably observable across all lower catchment sites, at the time of sampling, as shown in the photos of Appendix A. A sample of these photos, showing the difference in water clarity during dry and wet weather, is shown in figure 23 below.

Figure 23: Photographs of Site T6 during dry (left) and wet (right) weather, showing the decreased water clarity during wet weather as a result of increased sediment load, that was a common occurrence across all lower catchment sites (see Appendix A).

Sources of high sediment loads may include stream bank erosion, as a result of stock access to the stream and a lack of riparian width and suitable bank vegetation resulting in unstable banks. While there was visible evidence of stock accessing streams, and unstable banks at the time of sampling, the RHA condition scores indicated that on average, the bank erosion was in the lower range of “optimal”, while riparian width and bank vegetation were on average “marginal” across the lower catchment. As such this indicates that while there is room for improvement in the stability of the stream banks, particularly in the width of the riparian zone and the quality of vegetation on the stream banks, there may be other critical sources of sediment from within the catchment. Erosion also occurs in the wider catchment, particularly in steeper sloped areas with minimal vegetation. During high rainfall events, these areas are likely to be hot-spot sources for sediment generation and transport (HBRC, 2017). Without appropriate riparian buffer zones, consisting of a diverse assortment of mature, native vegetation, this sediment is carried as run-off into the streams.
