Hawke's Bay Regional Council

STREAM AND RIVER ASSESSMENTS FOR CYCLONE GABRIELLE RURAL RECOVERY

WHARERANGI STREAM – PUKETITIRI ROAD

16 APRIL 2024

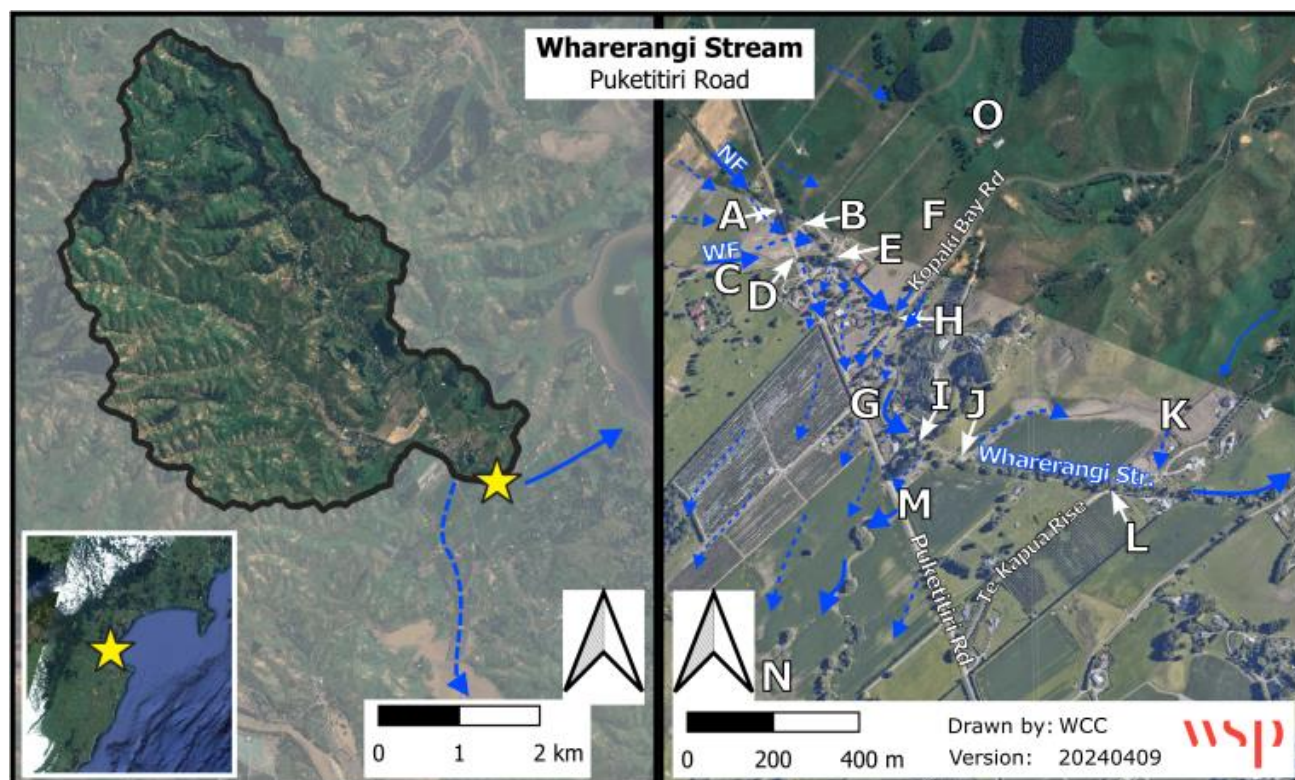
Figure 1. *Left*: The contributing catchment (18.5 km²) drains southeasterly toward the site where it is diverted (approximately point I) into a constructed channel (solid arrow) that discharges to the Ahuriri Lagoon. The original flow path discharged (hashed arrow) to the Tutaekuri River and was reactivated during Cyclone Gabrielle. *Right*: Post-Cyclone Gabrielle (CG) imagery reflects very active floodplain engagement and sediment-rich conditions. The Area of Concern (AoC) is from the Puketitiri Road crossings (points A and D) of the North Fork (NF) and West Fork (WF), respectively, down-valley to the Te Kapua Rise vicinity. Flow to the west (left) of Puketitiri Road discharges to the Tutaekuri River while flow to the east (right) of Puketitiri Road discharges to Ahuriri Lagoon. Hashed arrows represent overbank flow paths and are indicative, Not definitive. Lettered points are referenced in the text and mark the same locations as in Figure 3.

The Area of Concern (AoC) is approximately 1 km of valley from the Puketitiri Road crossing of the North Fork (Figure 1, *WF*, point *A*) to the vicinity Te Kapua Rise.

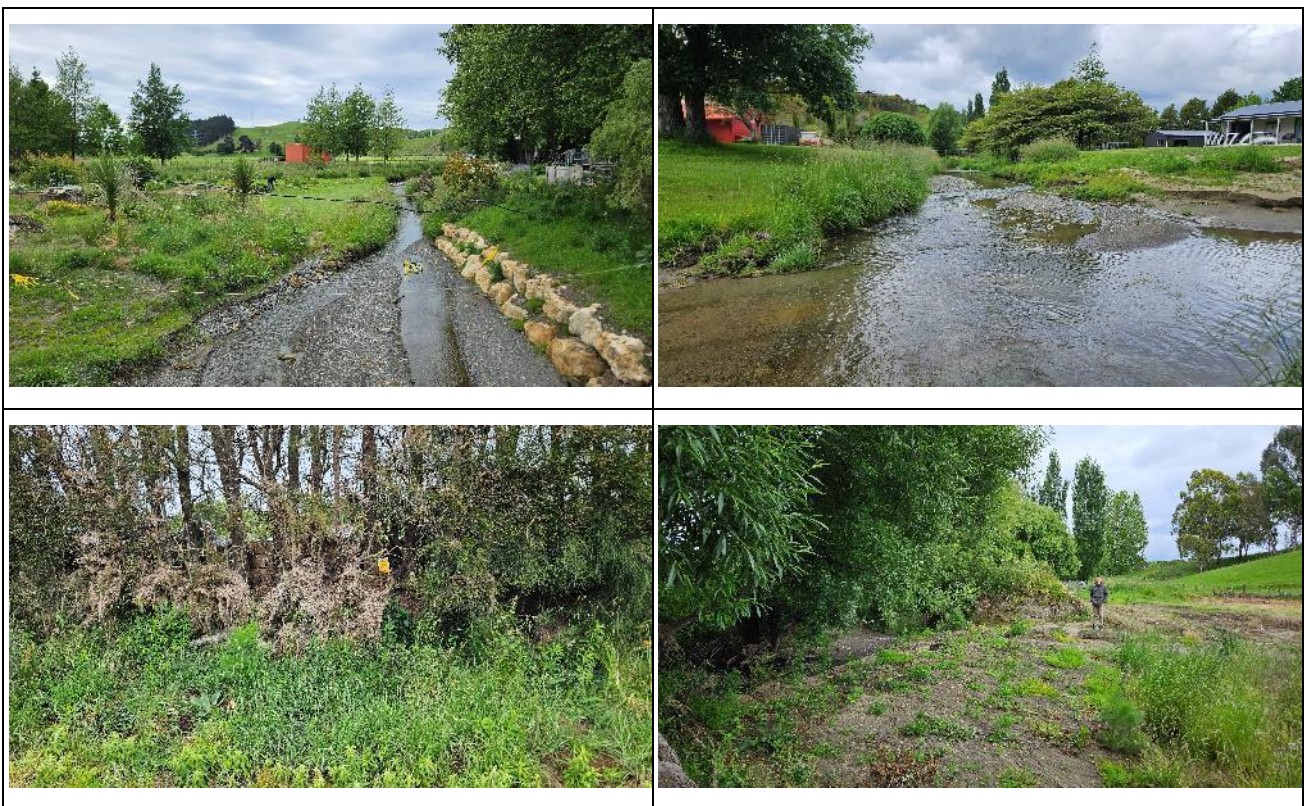
Figure 2. *Top Left*: Downstream view of the West Fork (WF) Wharerangi Stream from the Puketitiri Road (Figure 1, point *D*) looking toward the confluence with the North Fork. *Top Right*: Looking downstream from hardened ford crossing (Figure 1, point *E*) with farm (left) and residential (right) buildings close to the stream channel. *Bottom Left*: Flood sands and leaf litter deposited into hedgerow up ~1.2 m above Puketitiri Road surface in the vicinity of point *C* (Figure 1). *Bottom Right*: Looking upstream at the breach in the left-bank (camera-right) bund at point *J* (Figure 1).

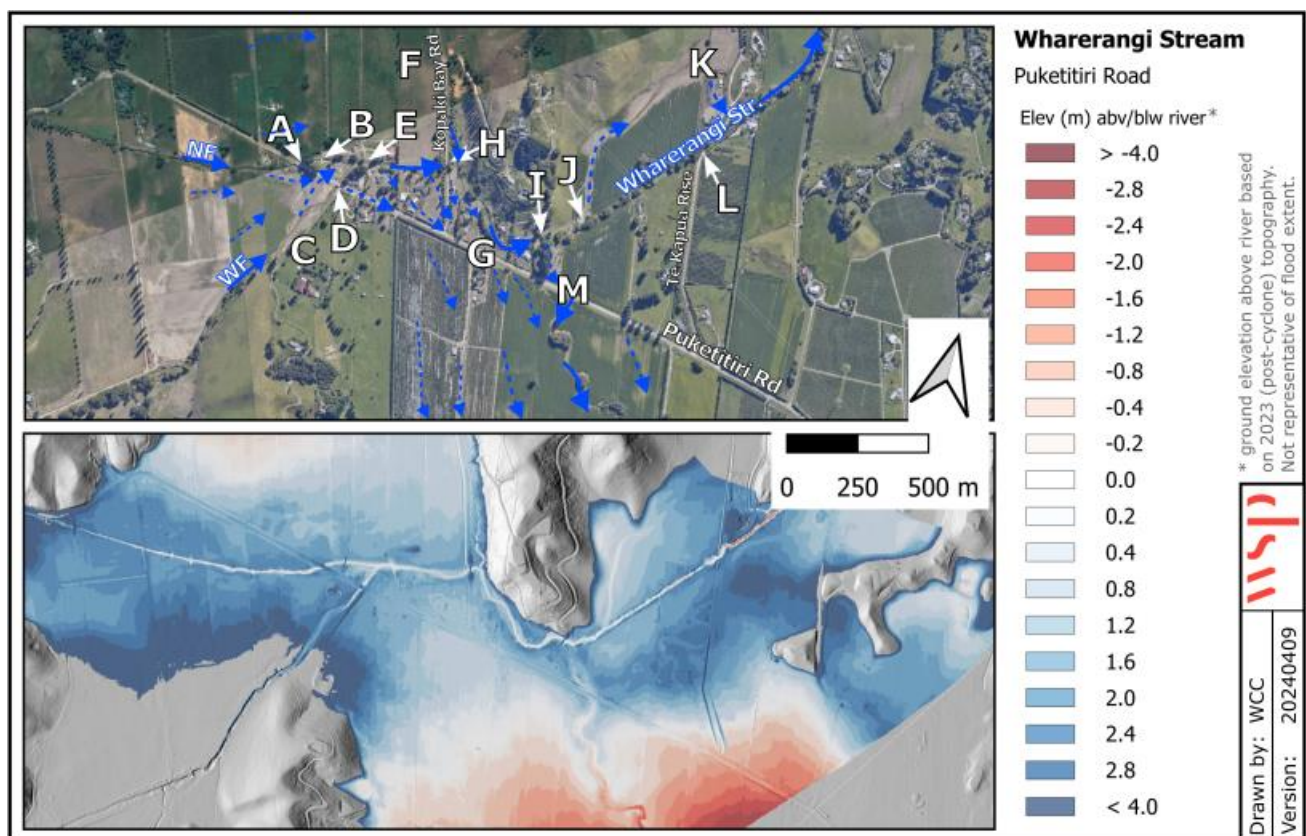
Figure 3. Post-CG imagery (top) and relative elevation (bottom) view of the site, inclusive of the AoC. Annotation notes same locations as Figure 1 and is discussed in the text. The image and elevation data are post-CG and generally representative, but not specifically accurate of channel and bar locations at the time of the 7 November 2023 visit.
